ANNUAL REPORT FOR 2002

**Mud Creek Mitigation Site
Henderson County
Project No. 8.T842404
TIP No. A-10 WM**

Prepared By:
Office of Natural Environment & Roadside Environmental Unit
North Carolina Department of Transportation
December 2002/ Revised March 2003

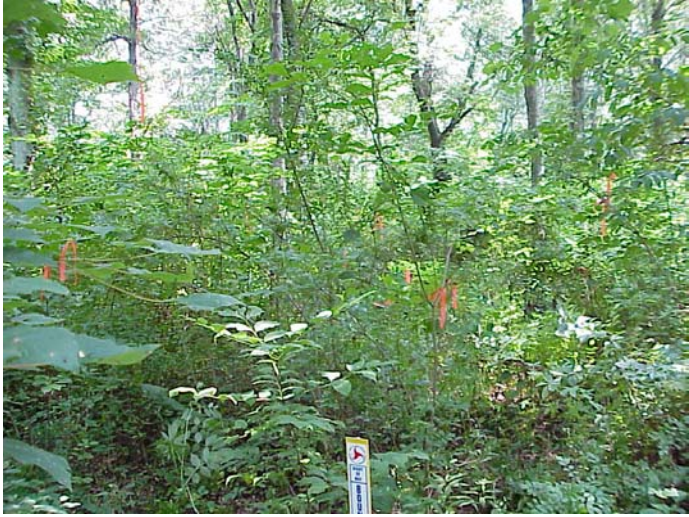
Photo 1 (Transect)

Transect: A 100' x 30' (0.07 acre) transect was installed within the Wetland Enhancement Area during the July 2001 monitoring visit. GPS coordinates for this transect could not be obtained due to the dense tree canopy cover. The approximate location of the transect is shown on the attached map.

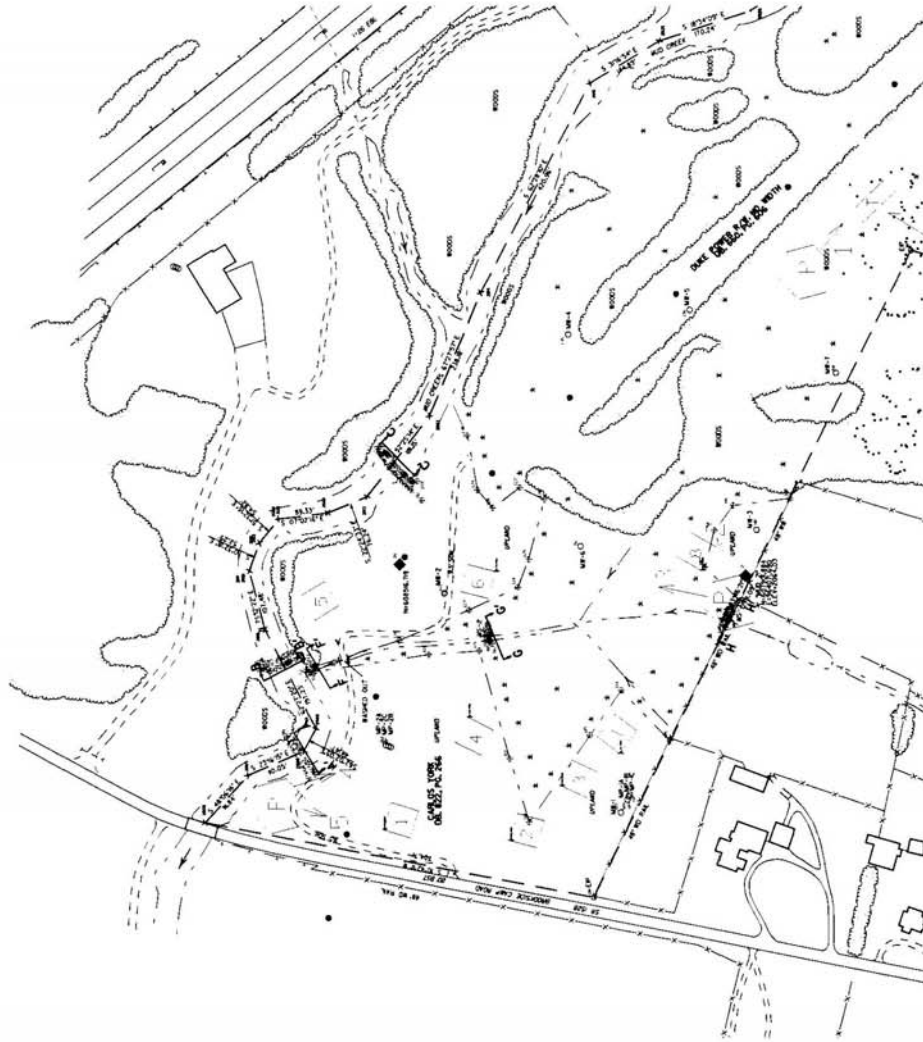
FLORA AND PHOTO LOCATIONS

(P) Photo Locations
 // Transect Locations

Approximate Transect Location
